The
San Francisco Earthquake and Fire

A BRIEF HISTORY OF THE DISASTER

A Presentation of Facts and Resulting Phenomena, with Special
Reference to the Efficiency of Building Materials
Lessons of the Disaster

A. L. A. HIMMELWRIGHT, C.E.

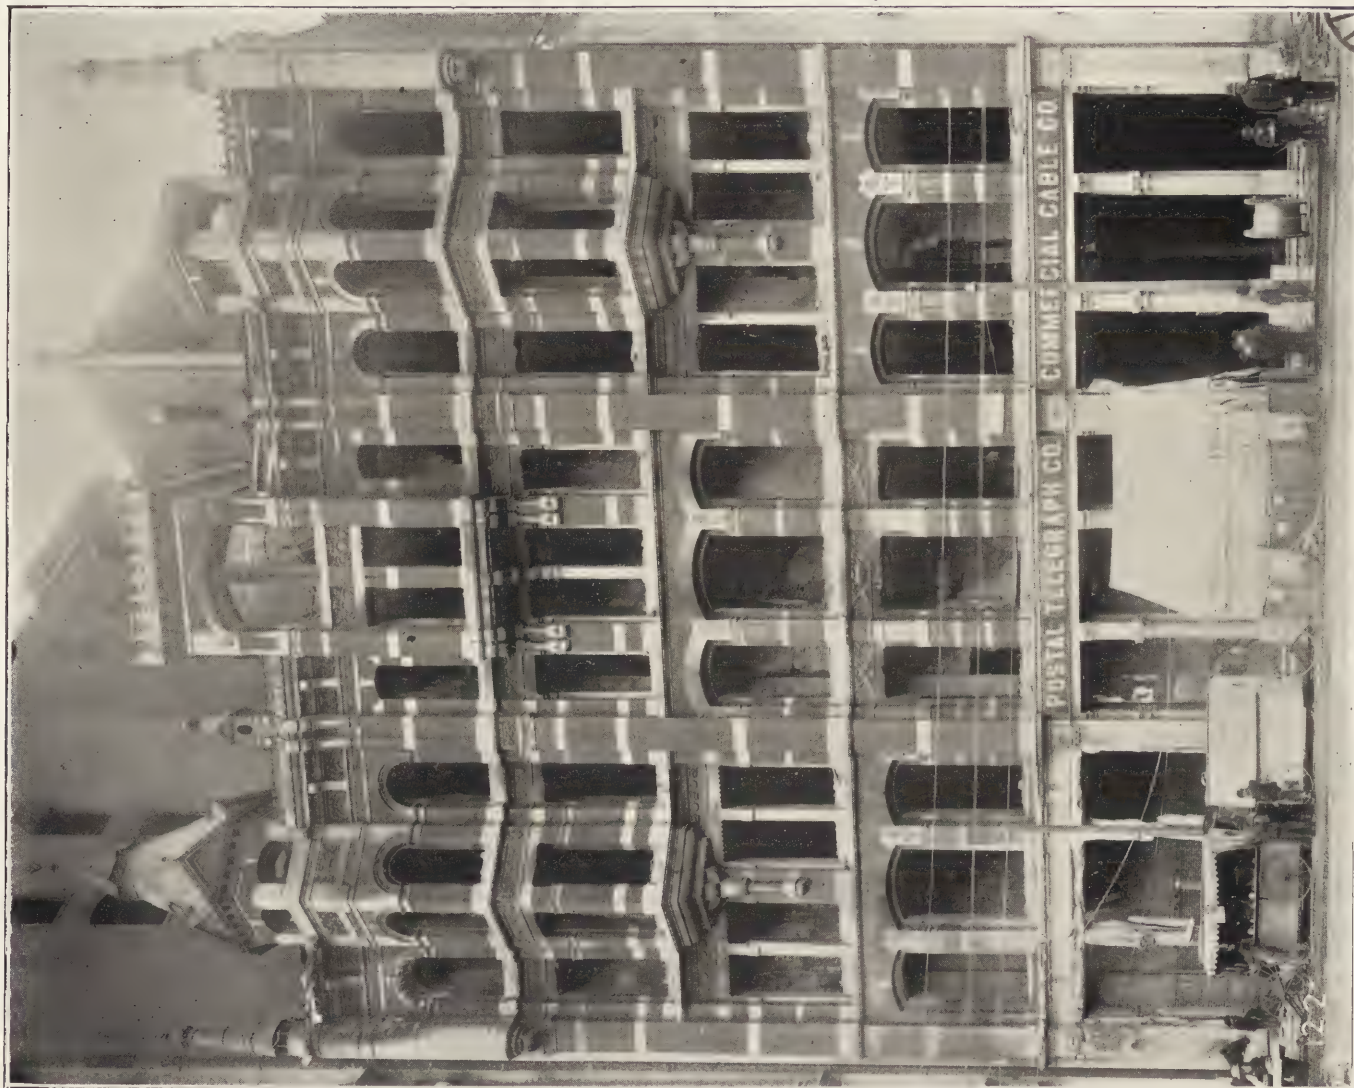
HOBART BUILDING. Market Street, between Montgomery and Sansome Streets. The facade consists of gray granite for the first story and common brick with granite ornamentation above. The granite is badly spalled on the west side at the first-story level, but the front is little damaged elsewhere. The interior is in bad condition, large sections of the flooring having collapsed on account of exposed girders and beams in the basement. The steel framework is badly distorted and warped. The fire-proof floors consist of segmental arches of common brick and brick concrete, with flat wire lath and plaster ceilings underneath. The partitions and column protection are of hollow tile blocks. A large proportion of the partitions are wrecked. The column covering is in fair condition. The flat wire lath and plaster ceilings failed in many places on account of a supporting clip of poor design.

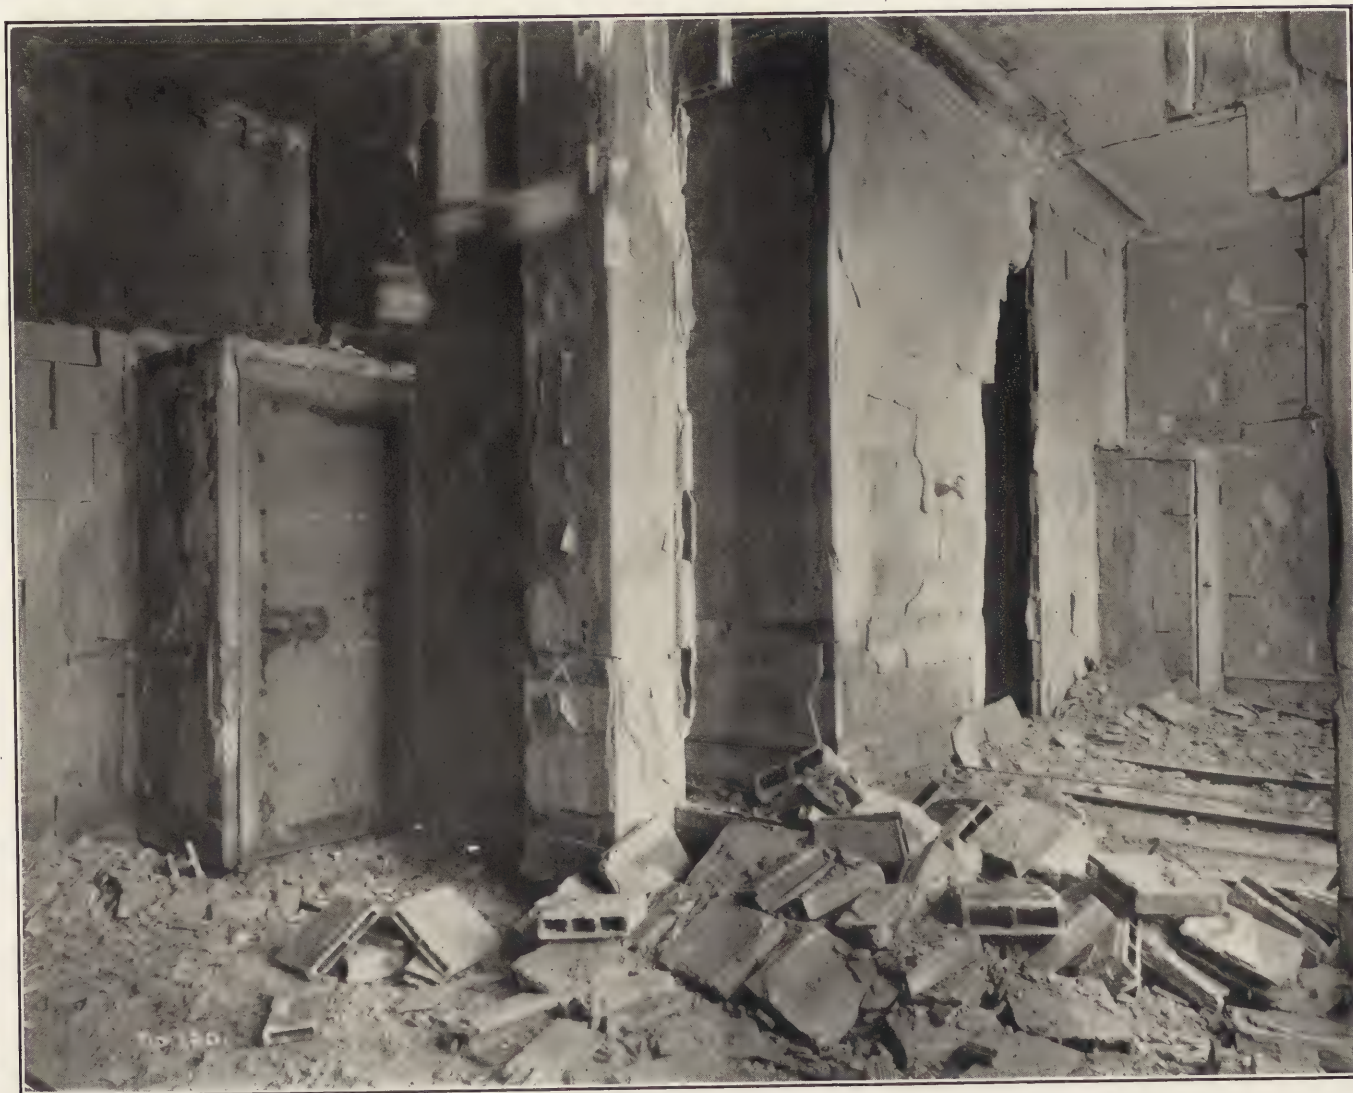
HOBART BUILDING. Fourth Story. Showing the failure of the hollow tile 3" and 4" partitions, and of the hollow tile protection around the vaults. The column protection was of two-inch hollow tile blocks. The workmanship and material being of a better grade than that of the partitions, in many cases the column protection is but slightly damaged where the partitions are completely wrecked around it.

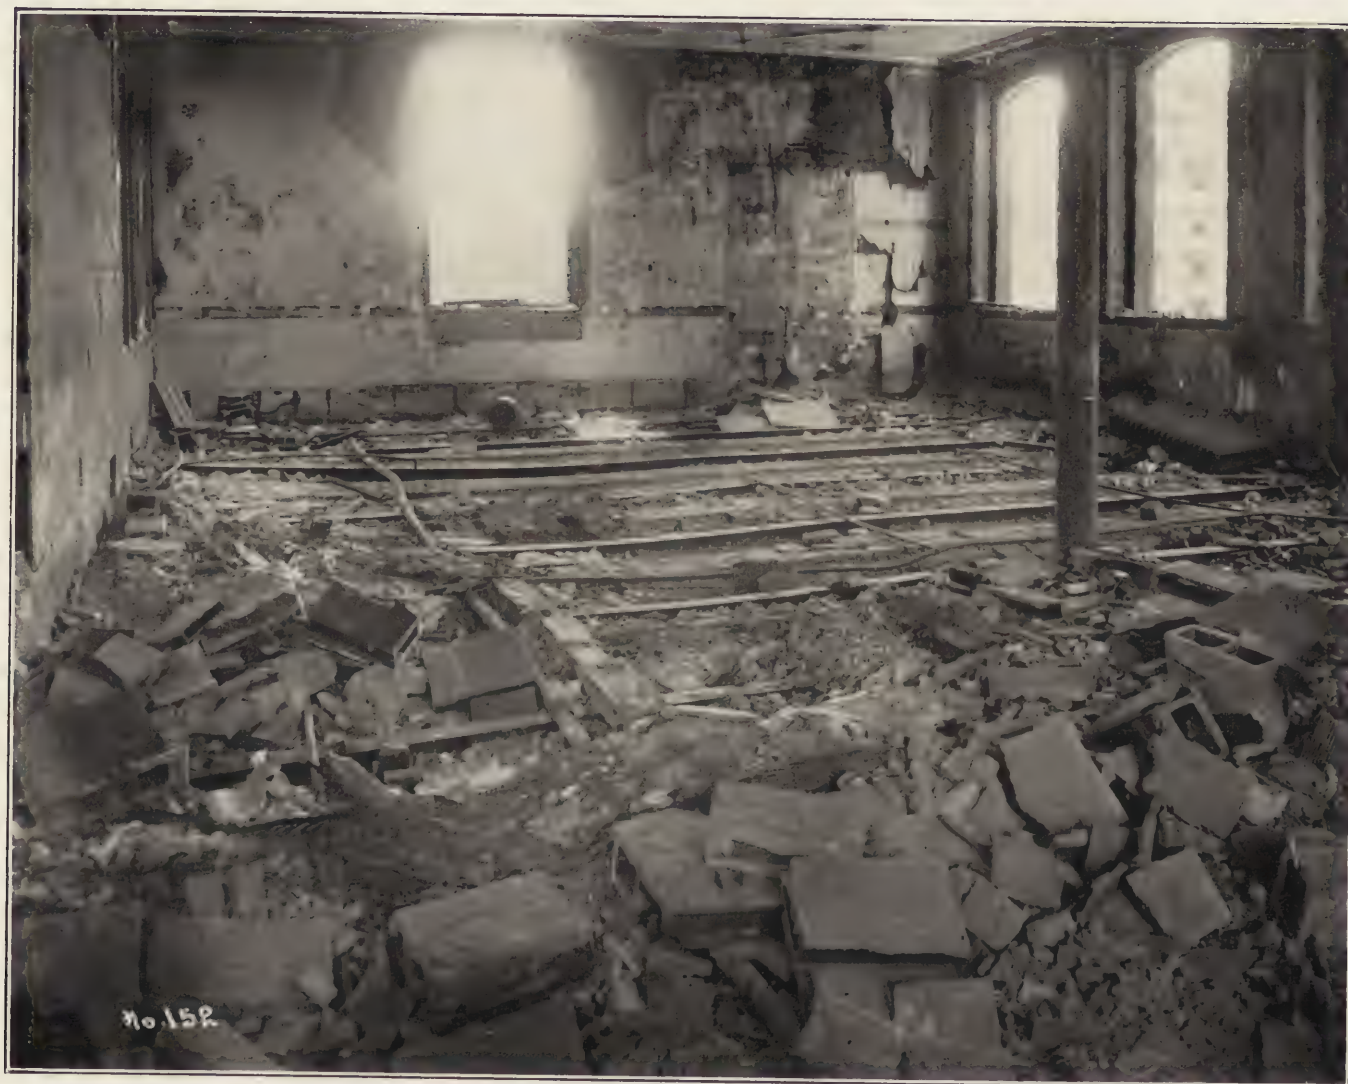
HOBART BUILDING. Fourth Floor. Showing the tops of the deflected and warped floor beams, which projected above the segmental brick arches. The regular concrete filling between the floor arches and the wood floor finish was omitted. The burning of the wood floor heated these unprotected beams sufficiently to distort them as shown.

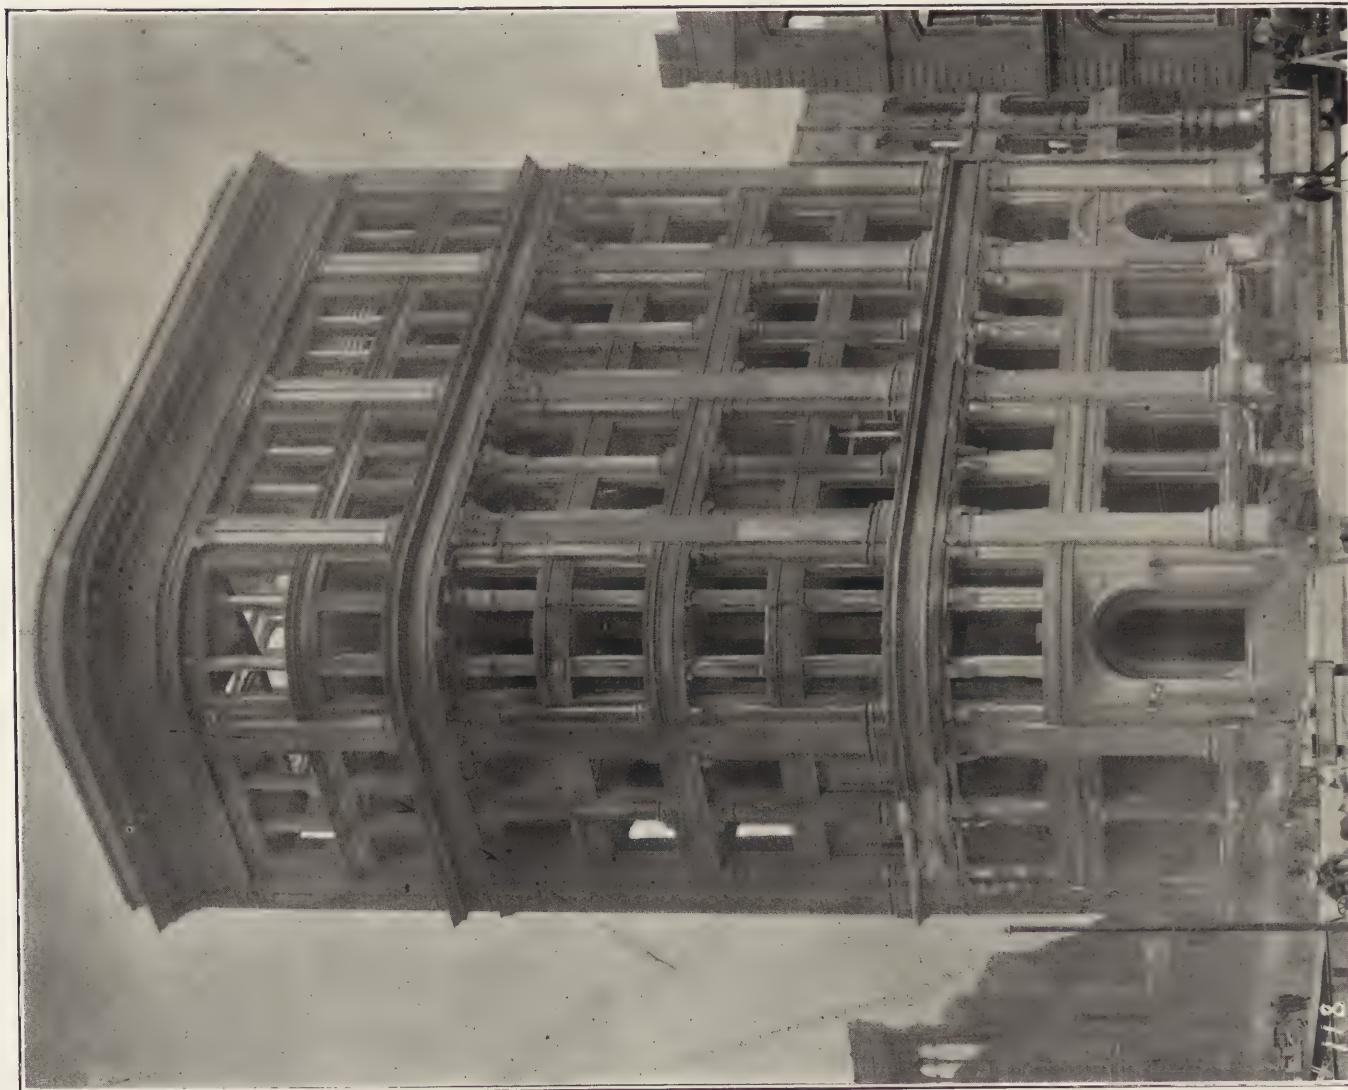
MUTUAL LIFE BUILDING. Southeast Corner Sansome and California Streets. The facade consists of granite for two stories and pressed terra cotta brick with terra cotta ornamentation above. The granite is badly spalled around the window openings, but the terra cotta is only slightly damaged. The upper portion of the building was badly wrecked on account of the collapse of one of the large trusses supporting the roof. This collapse was caused by the failure of the hollow tile partitions which were designed to protect it. The rear walls are considerably damaged by earthquake cracks and the collapse of the roof truss. A normal fire in this building damaged the soffits of the hollow tile floor blocks in numerous places. Many of the partitions have fallen down, and the column protection is badly damaged. Safes from the upper stories broke through the hollow tile floors to the basement.

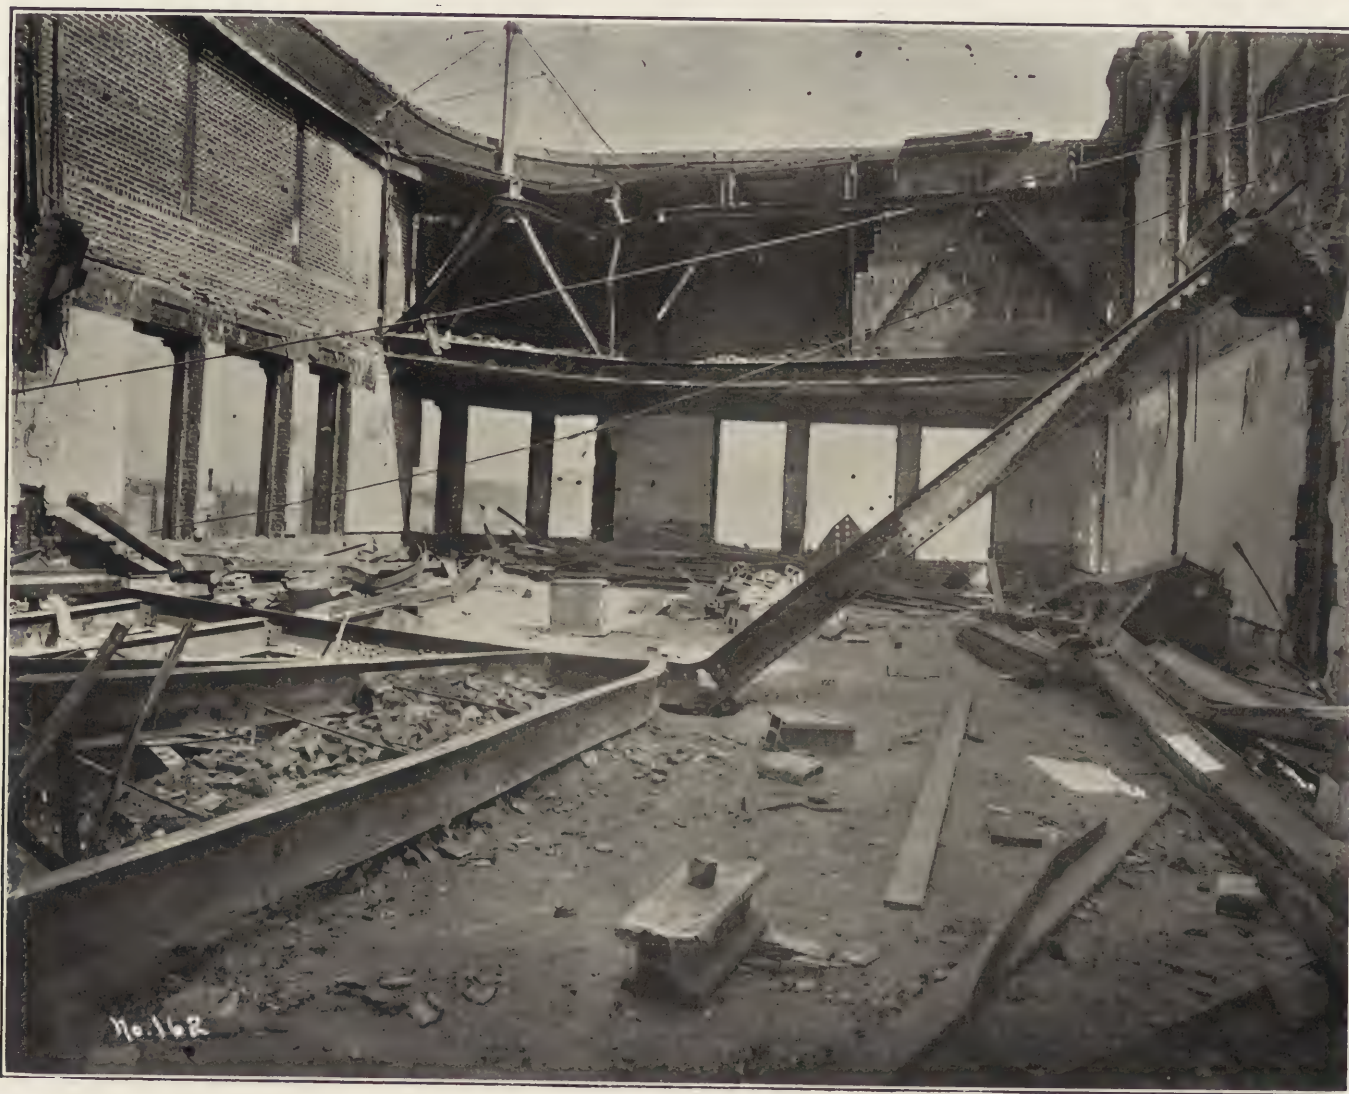
MUTUAL LIFE BUILDING. Ninth Story. Showing a truss supporting the roof in the rear, badly buckled and distorted by the fire. A similar truss in the centre of the building failed, as shown, bending the tops of the wall columns inward just below the gusset plate braces. The connection of the lower cord of the truss remains intact on the right-hand side. When the top cord buckled from the heat, all the load was transmitted to the bottom cord, which deflected and failed, parting at a beam connection and making a clean rupture, as shown, near the centre. These trusses were protected by hollow tile partitions, which failed, a section of one of the partitions remaining back of the rear truss on the right-hand side. The effect of the failure of this truss was to bulge the outside walls, which are now temporarily tied by cables, as shown. The falling of the steel work also knocked out several hollow tile arches, which broke out a great many others below them. The photograph was taken after some of the *débris* had been cleared away.

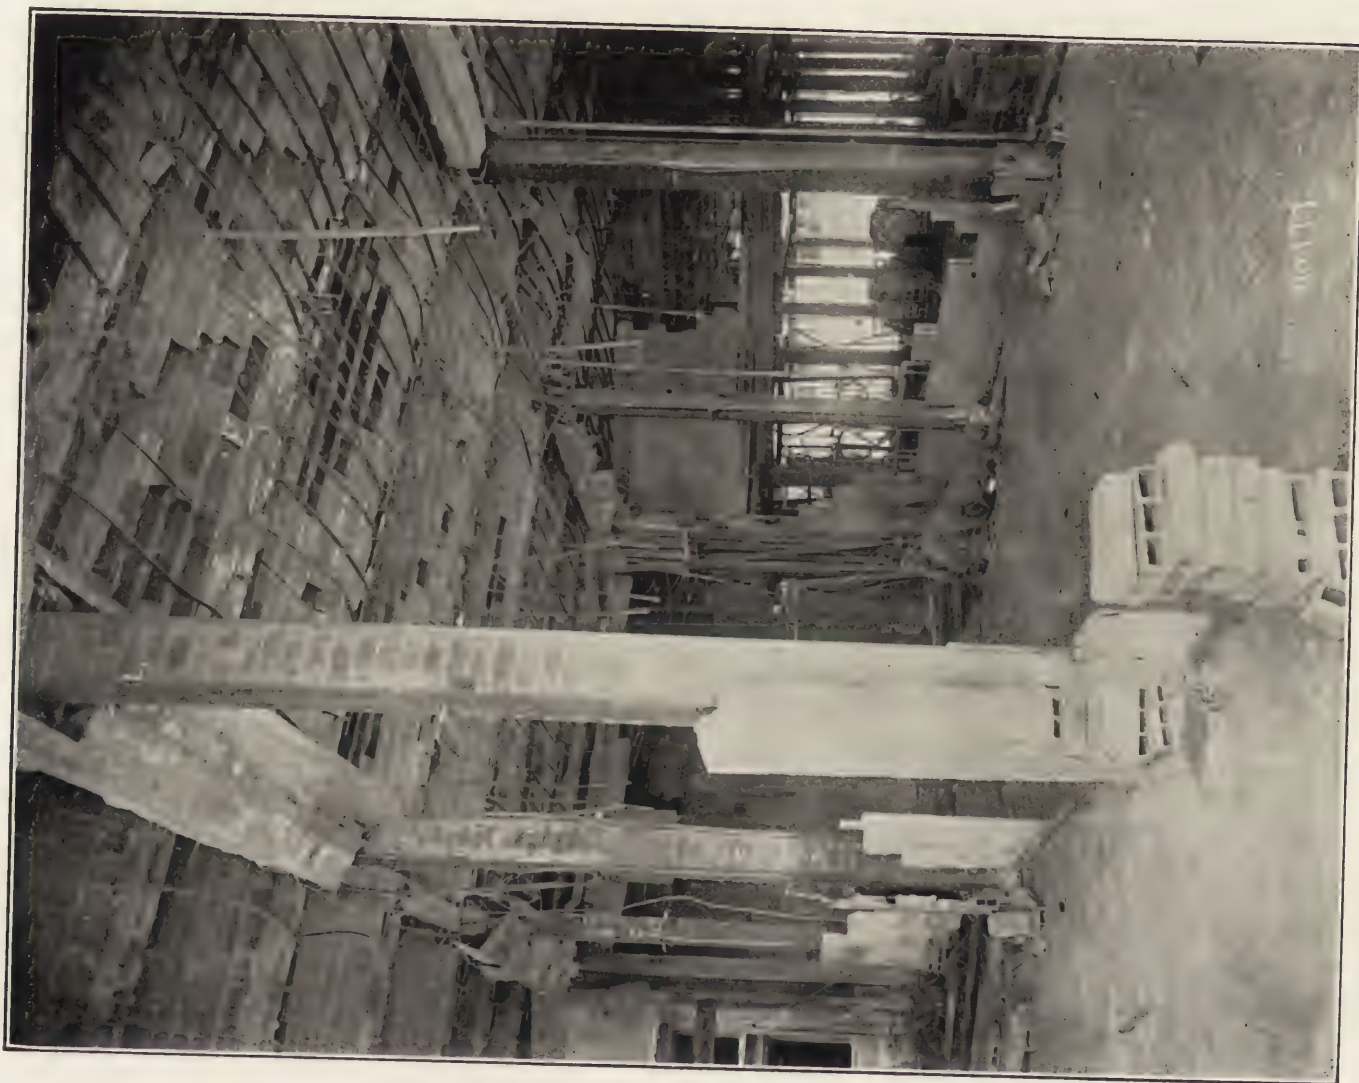
FLOOD BUILDING. First Story. The columns are protected by filling the re-entrant rectangular space with common brick, and then enclosing them with 3" hollow tile blocks. The Roebbing wire lath was laced to the ceiling furring with No. 16 B. & S. copper wire. The low fusing point of copper wire caused it to weaken, and allowed the lath and plaster to fall away from the supports, exposing the under side of the segmental hollow tile arches to the flames, which seriously damaged them as shown. In other portions of the building where the wire lath and plaster ceilings remain in place, the floor arches above are uninjured. The great height of this story was the cause of more damage to the partition blocks than in the other stories, which were of lesser height. The photograph was taken after much of the *débris* had been removed from the floors.

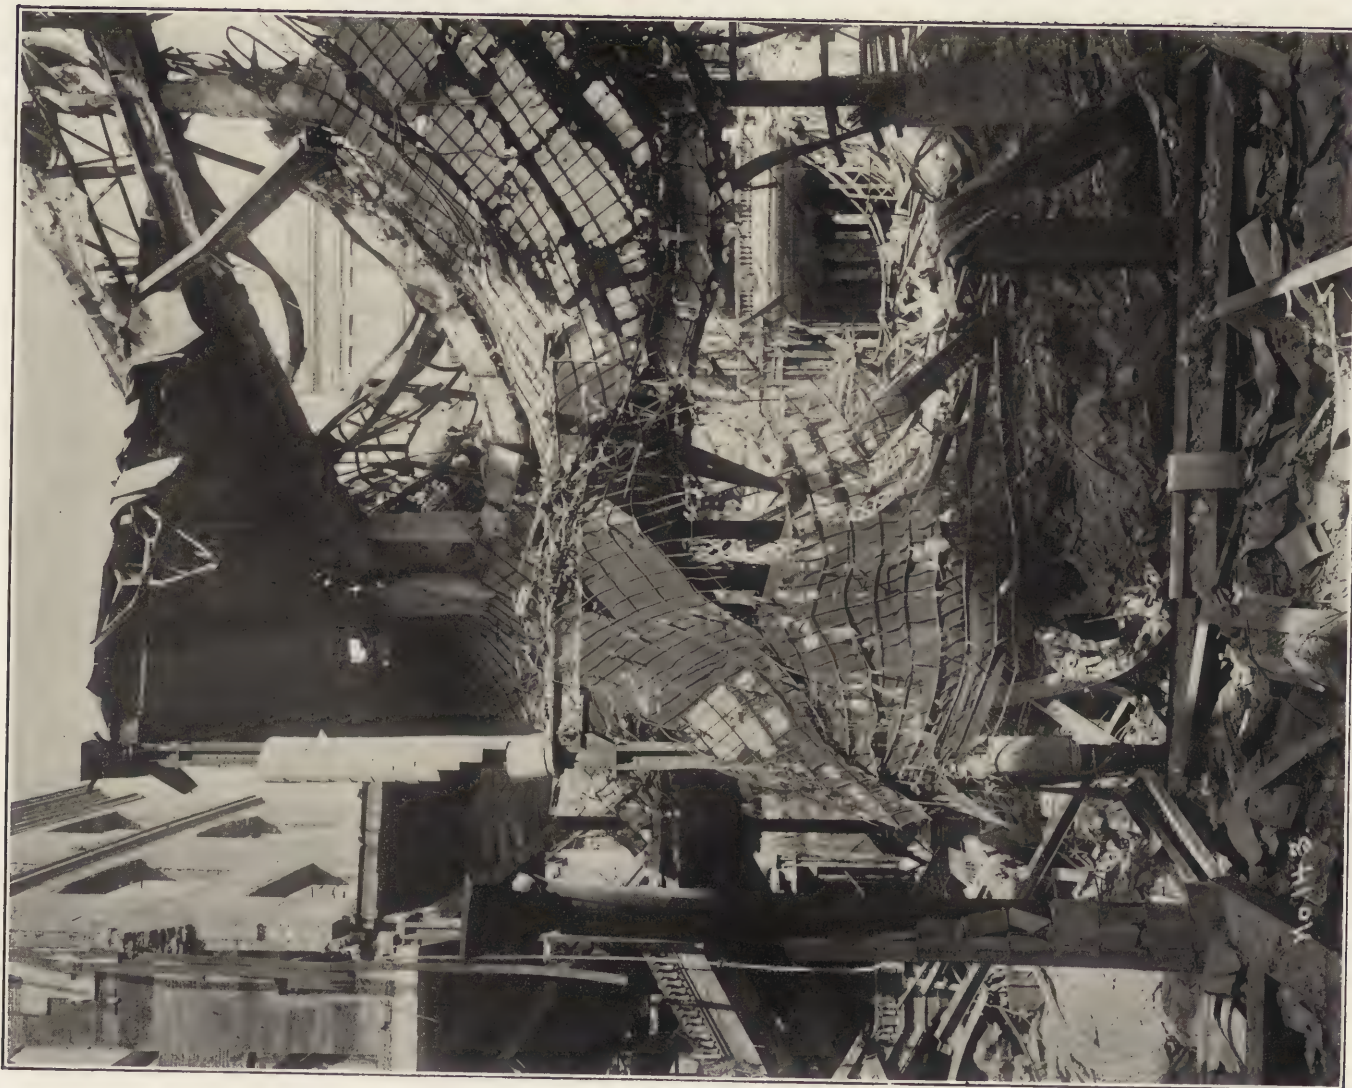
PARROTT BUILDING. First Story, looking toward the central light court from the south. Showing vast amount of wreckage and damage to the hollow tile floors, partitions, and column protection and the wire lath and plaster ceilings. Two columns buckled by the heat are in the right and left foreground.

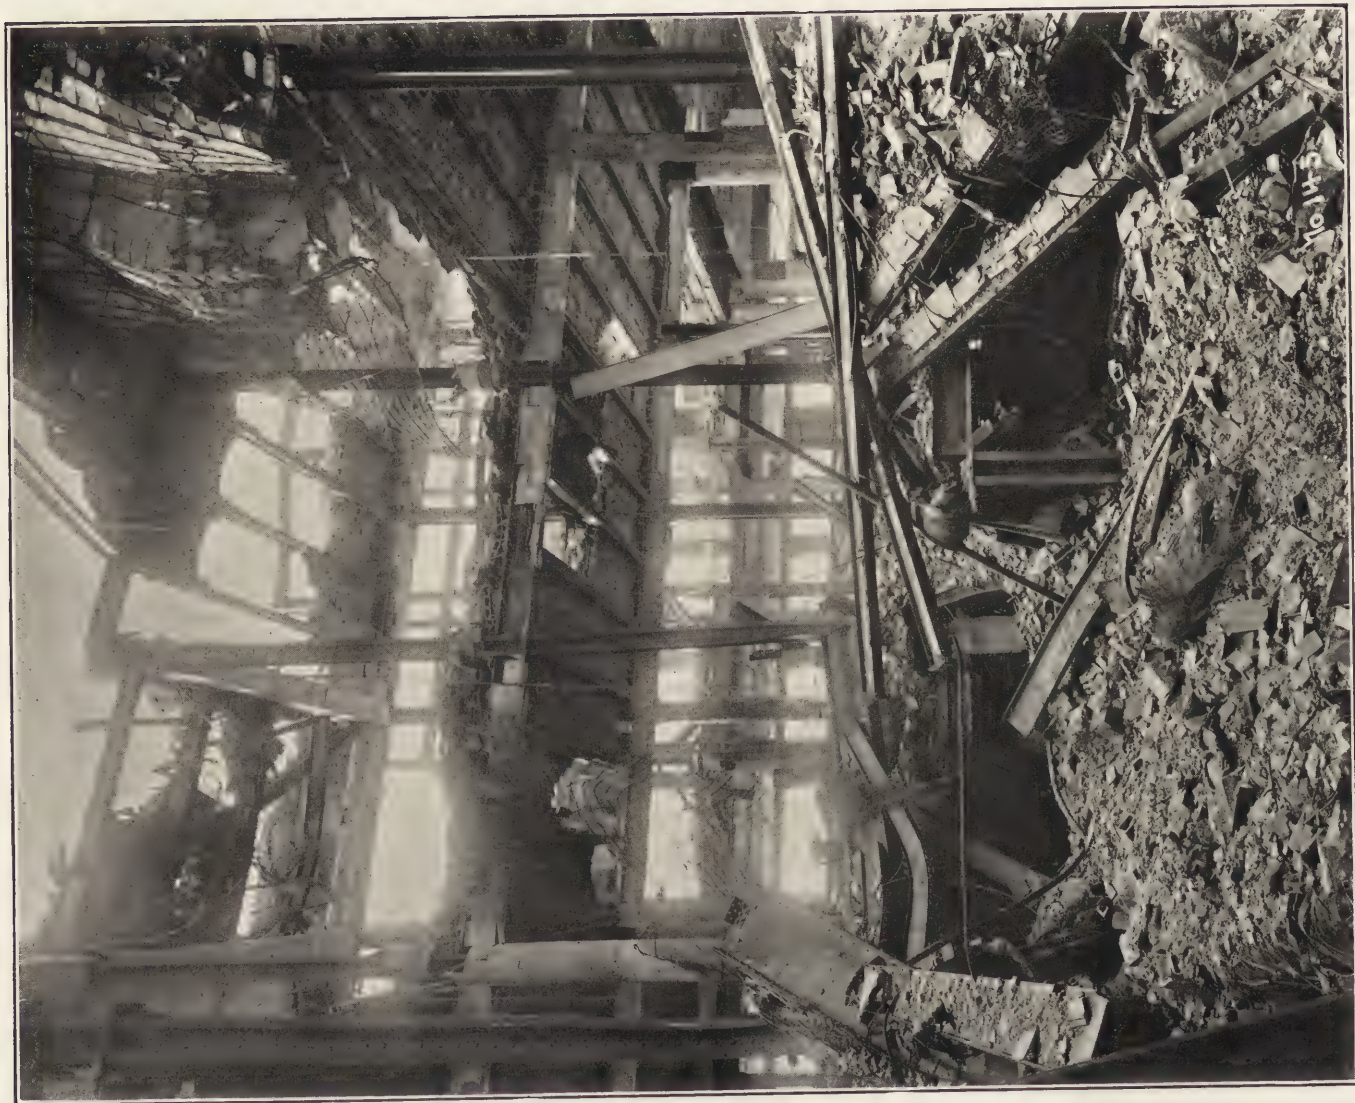
PARROTT BUILDING. First Story. Showing a buckled column in the centre foreground and the great damage to the hollow tile floors, column covering and partitions, caused by column failure. The flat wire lath ceiling of the third story with plaster adhering to it, is hanging down at upper right hand. A deflected column is at the extreme left.

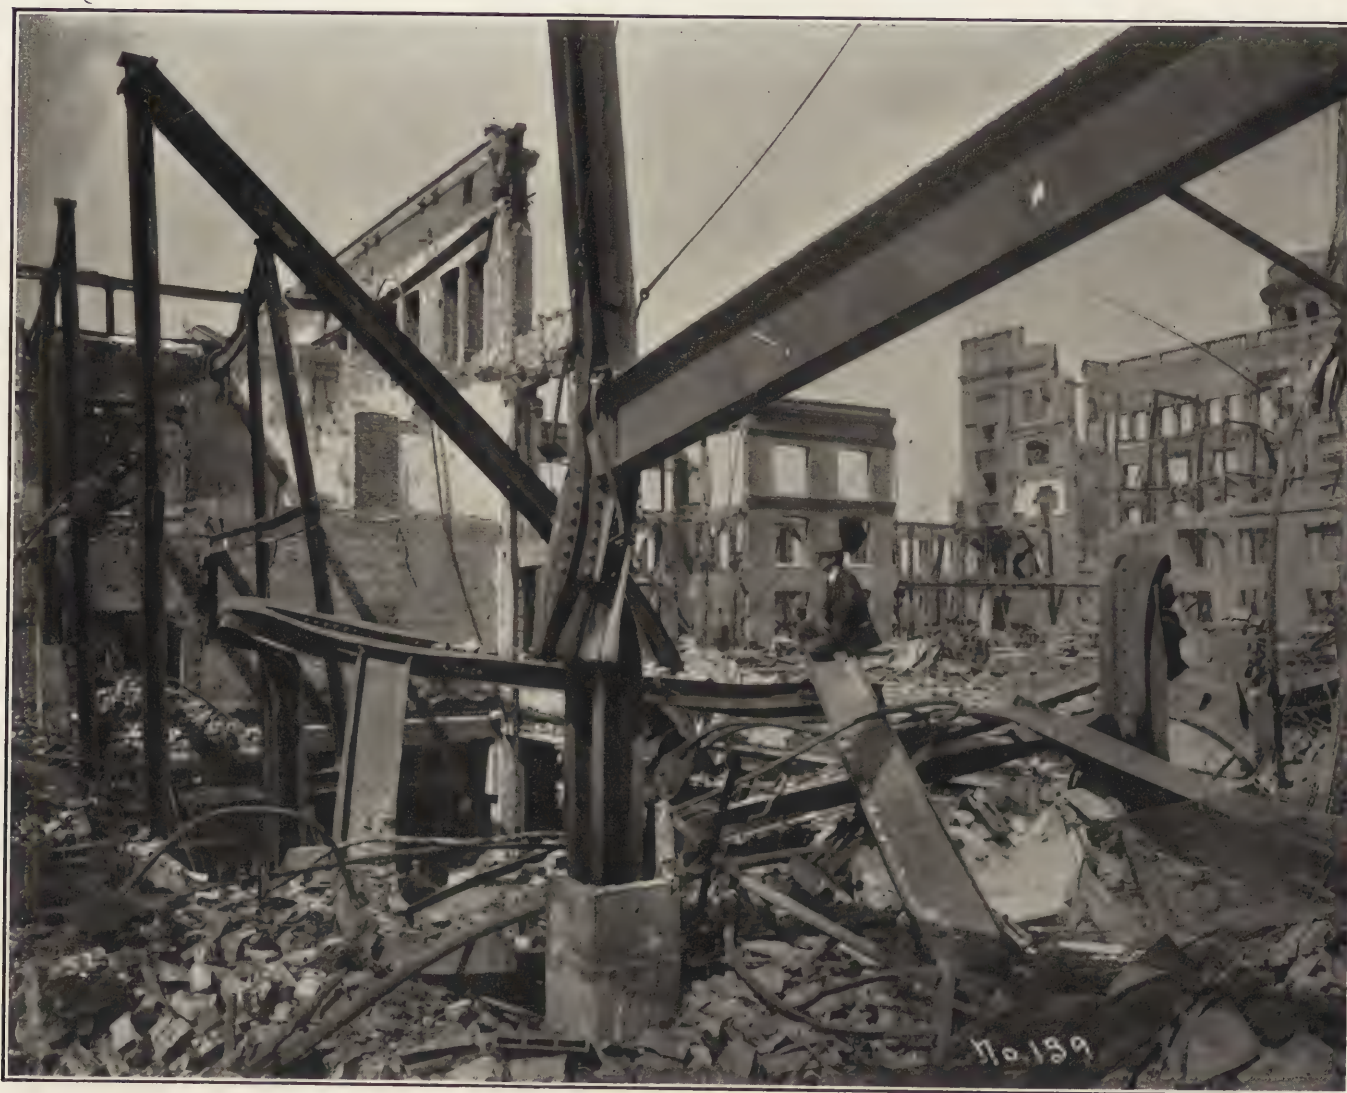
PARROTT BUILDING. Third Story. Showing the total wreck and disappearance of the upper portion of the building, which was of wood construction supported by steel framing. Three badly buckled columns are in the foreground. The wall columns of the steel frame were omitted above the third story, and the walls above this level were used as bearing walls. When the fire consumed the wood floors of the upper stories and wrecked the steel framing, large portions of the side and rear walls above the third story level were overthrown. Note the badly distorted remnants of the steel work projecting above this story.

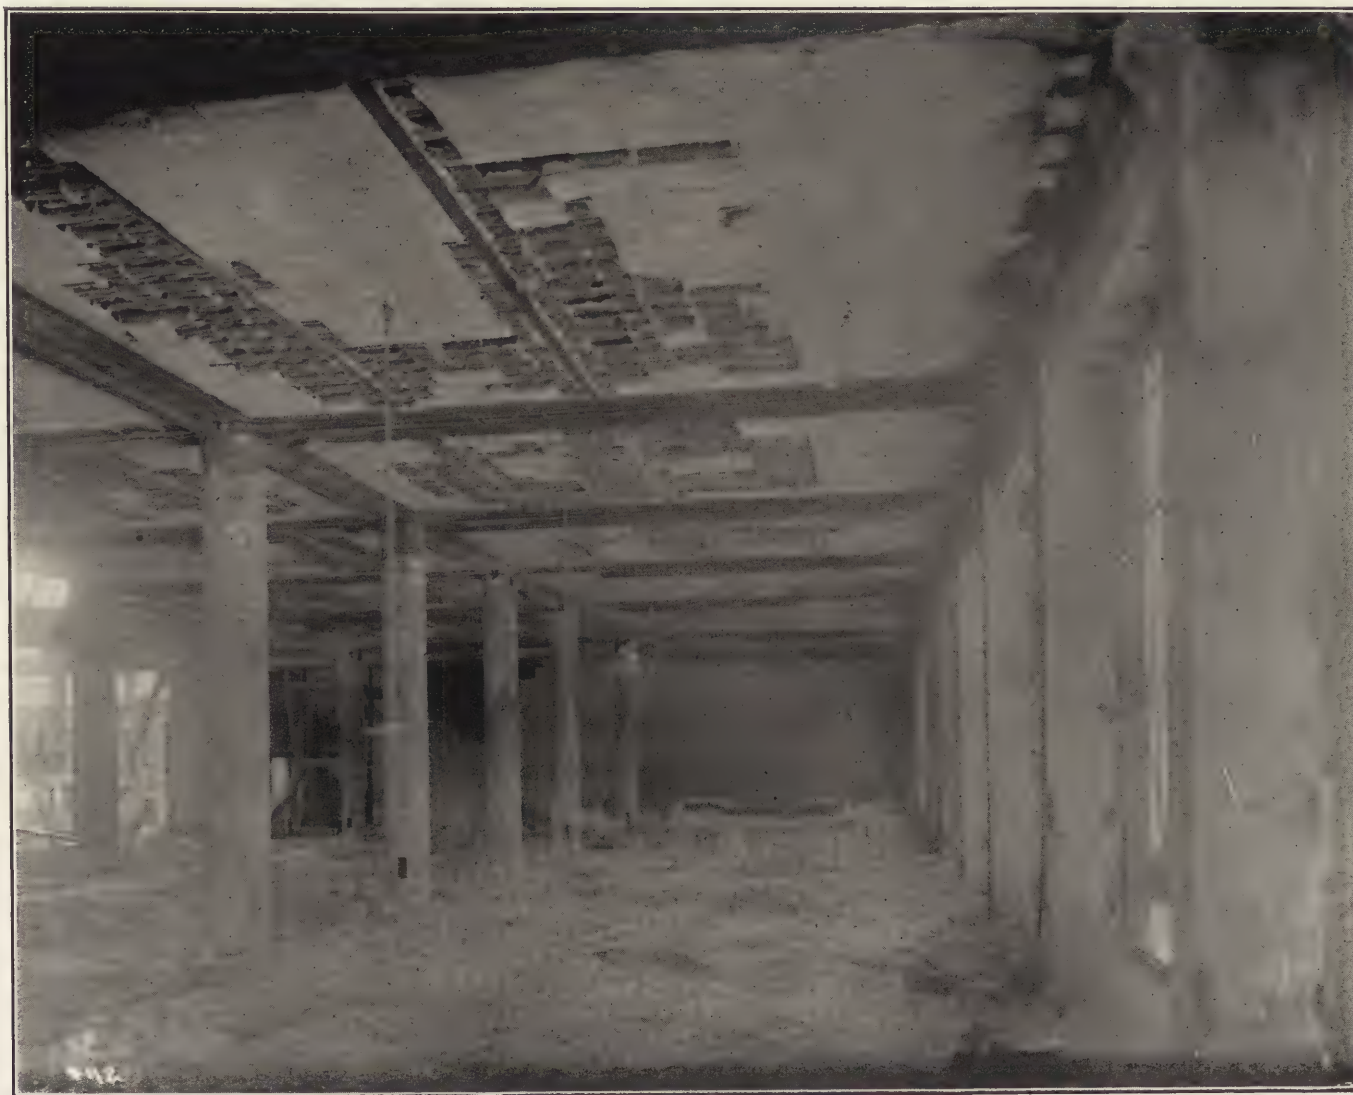
SPRING VALLEY BUILDING. First Story from the northwest corner of the building looking south. Showing the failure of the soffits of the hollow tile floors and the soffit protection of the beams and girders. The column protection is only slightly damaged in this story.

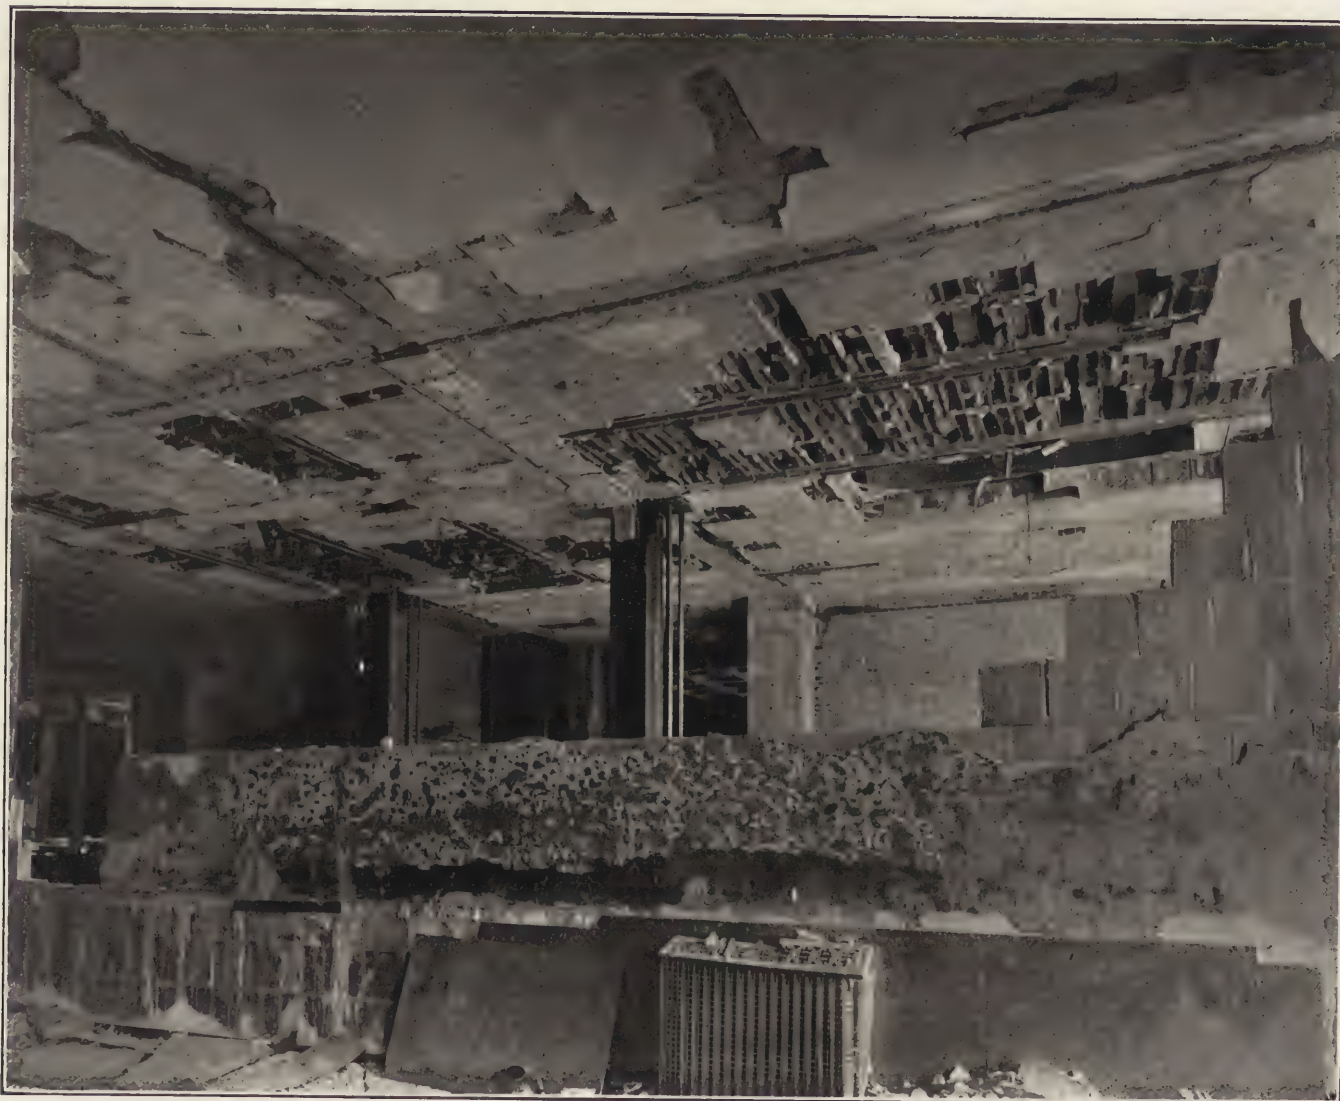
MILLS BUILDING. First Story. Showing the failure of the hollow tile column protection, and the damage to the hollow tile floors. A large proportion of the partition blocks in this building are down.

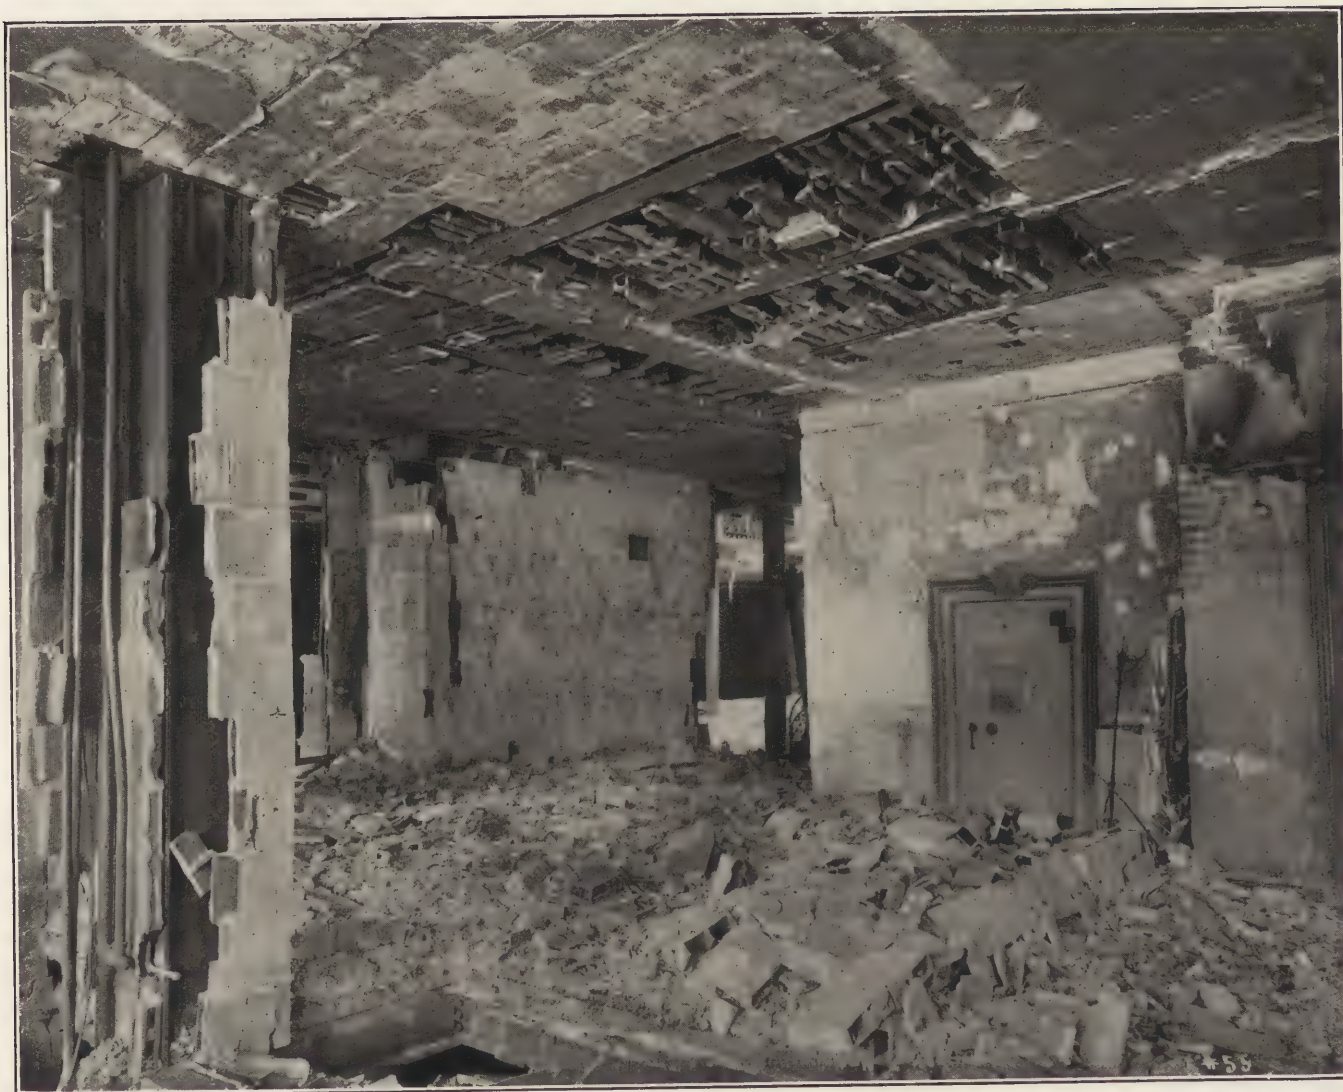
MILLS BUILDING. First Story. Showing the damage to the hollow tile floor arches, column covering, and partitions. The vault of the Scandinavian Bank, at the right, is uninjured. Note the separate shaft for pipes outside of the column protection, at the left.

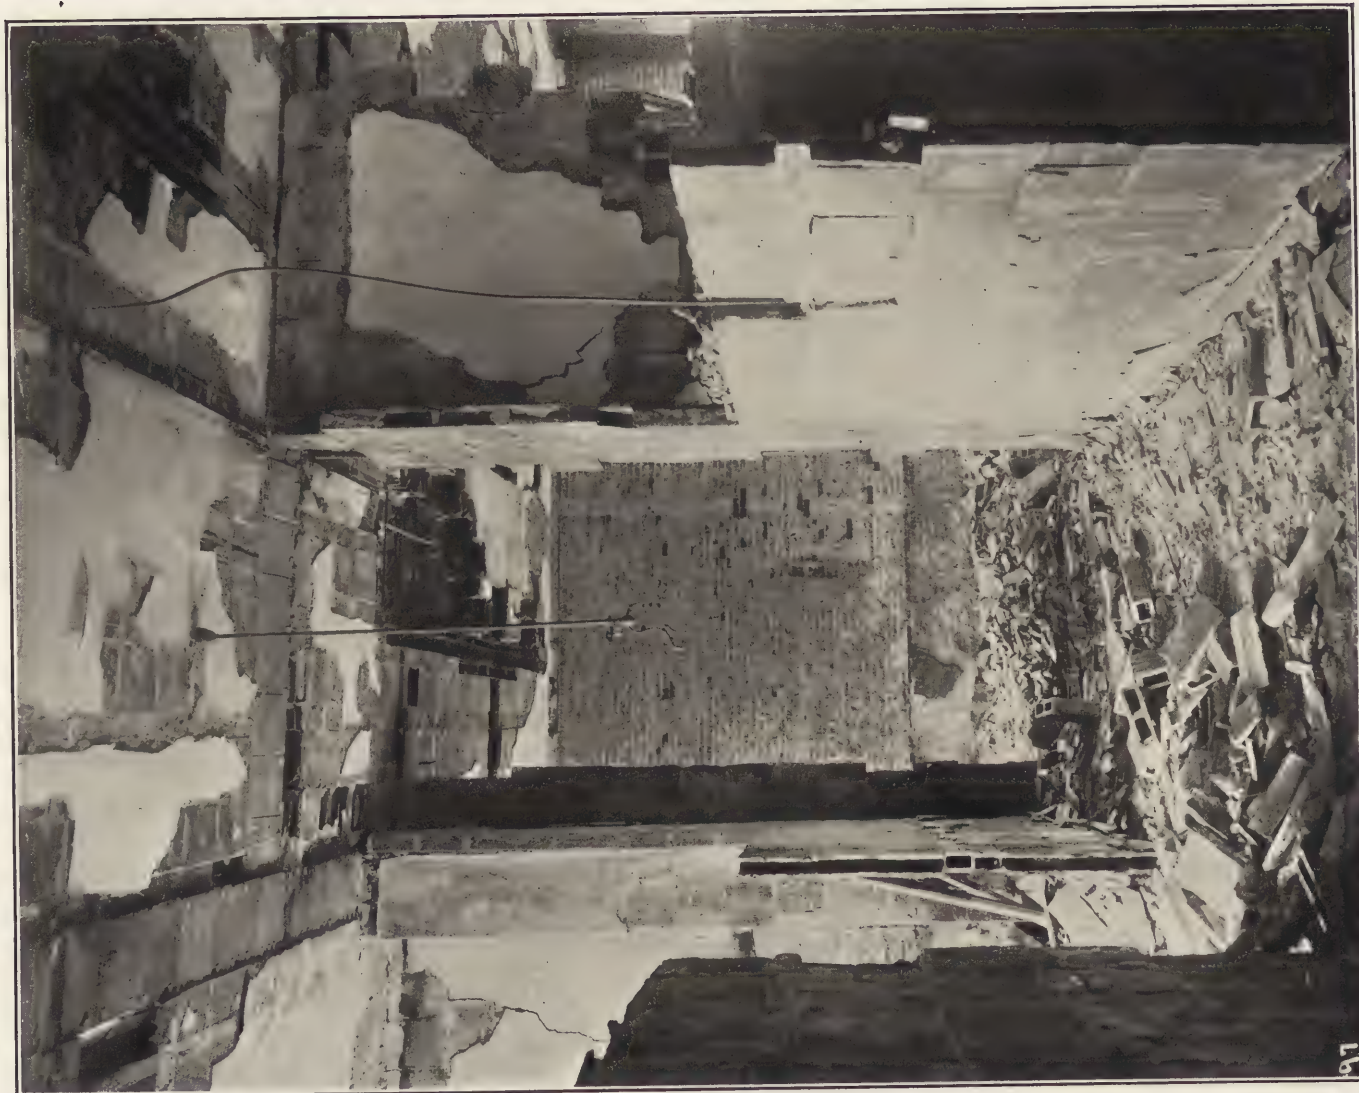
MILLS BUILDING. Second Story. Typical view showing the damage to the hollow tile floors and partitions. The soffit protection of the girders supported by the metal clips remains in place.

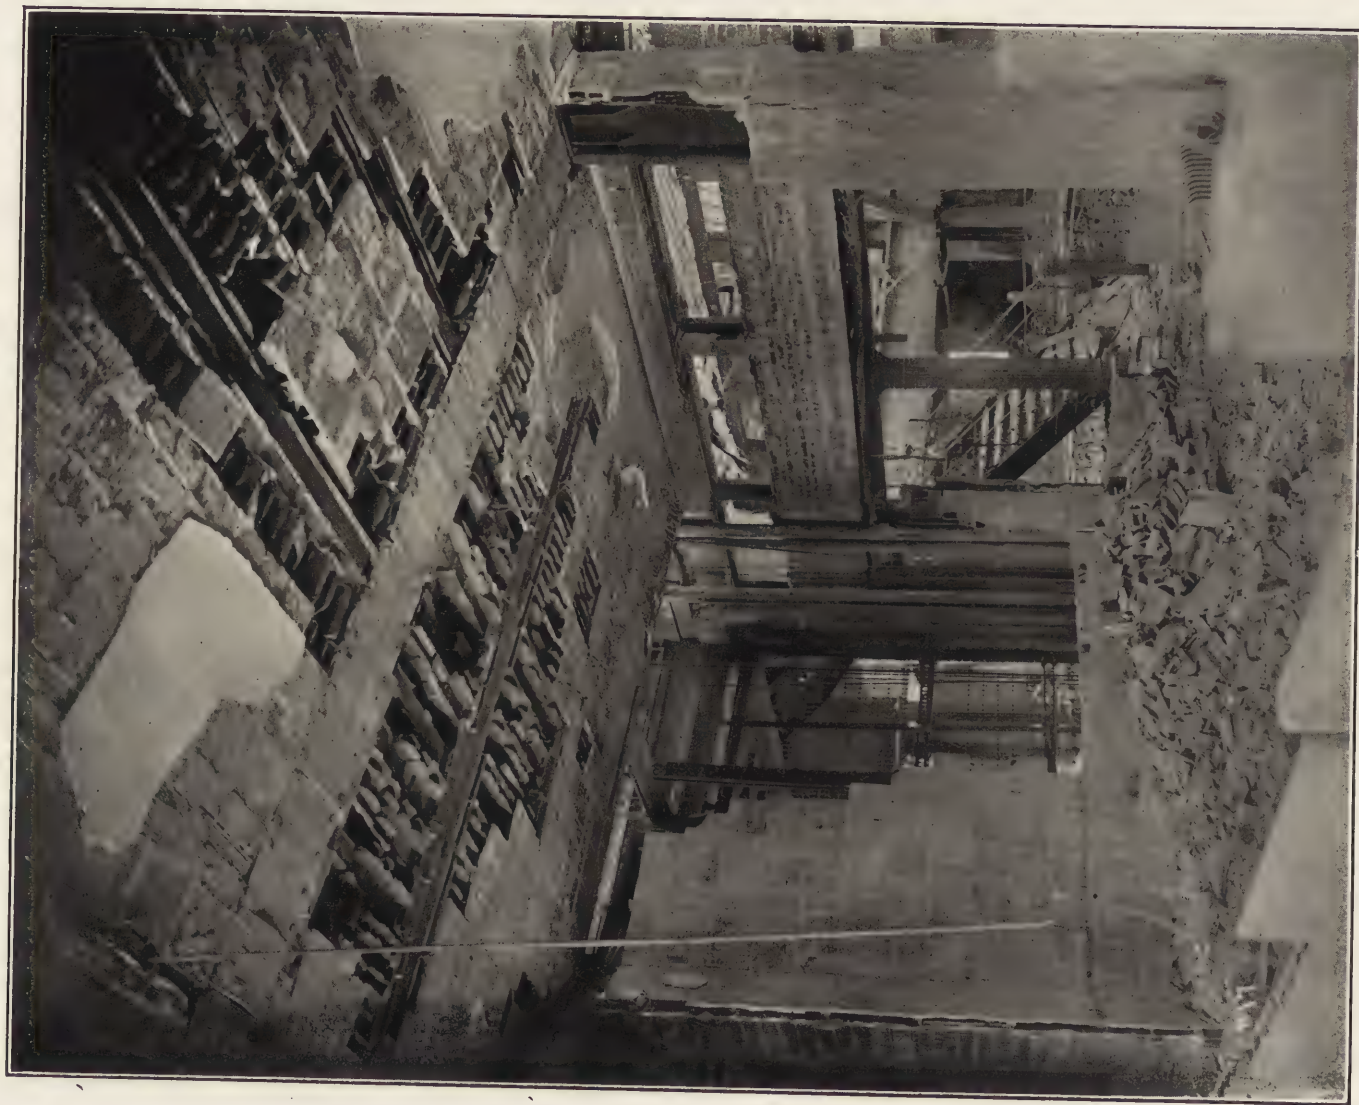
MILLS BUILDING. Second Floor. Typical view showing the damage to the floor arches, column protection and partitions. Note the metal clips holding the soffit protection of the double girders in place. Much damage was caused by the partition blocks falling into the elevator and stairway wells.
